MATERIALS RESEARCH LABORATORIES

MRL-R-958

EXPLOSION BULGE TESTING  
OF AUSTRALIAN HY-80 STEEL PLATE

J.C. Ritter and B.F. Dixon

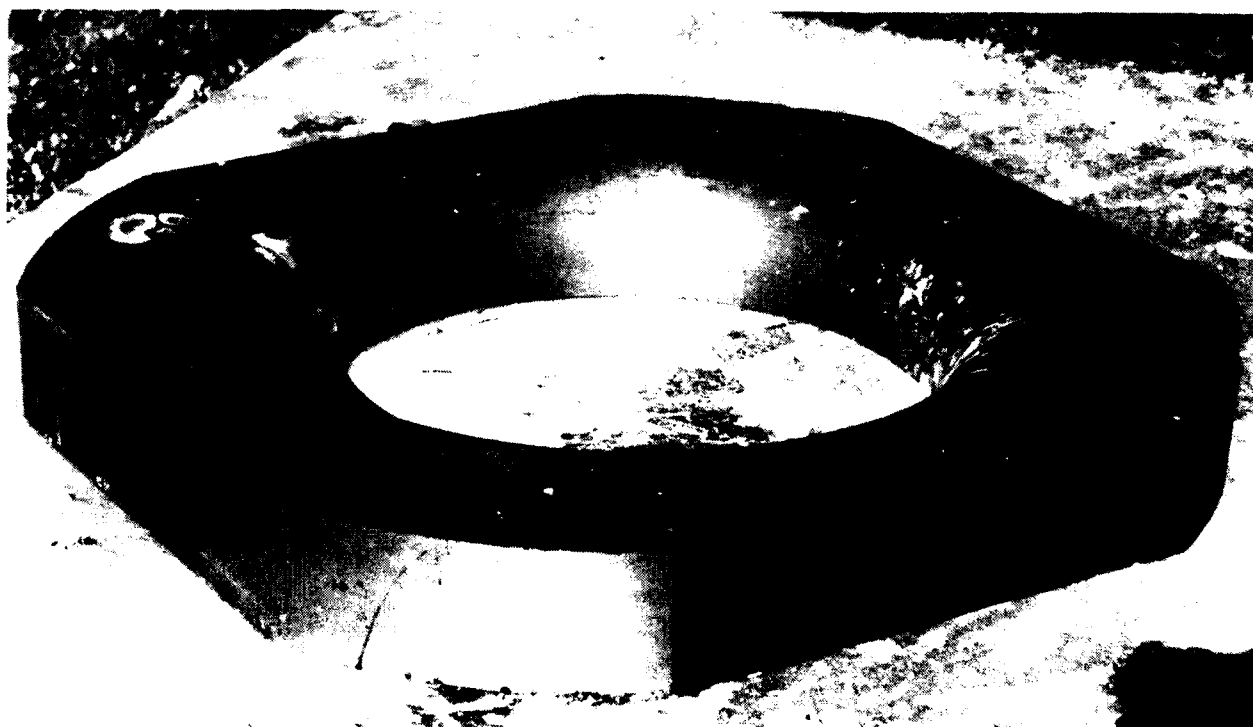
FIGURE 2 Die block in position over base plate.

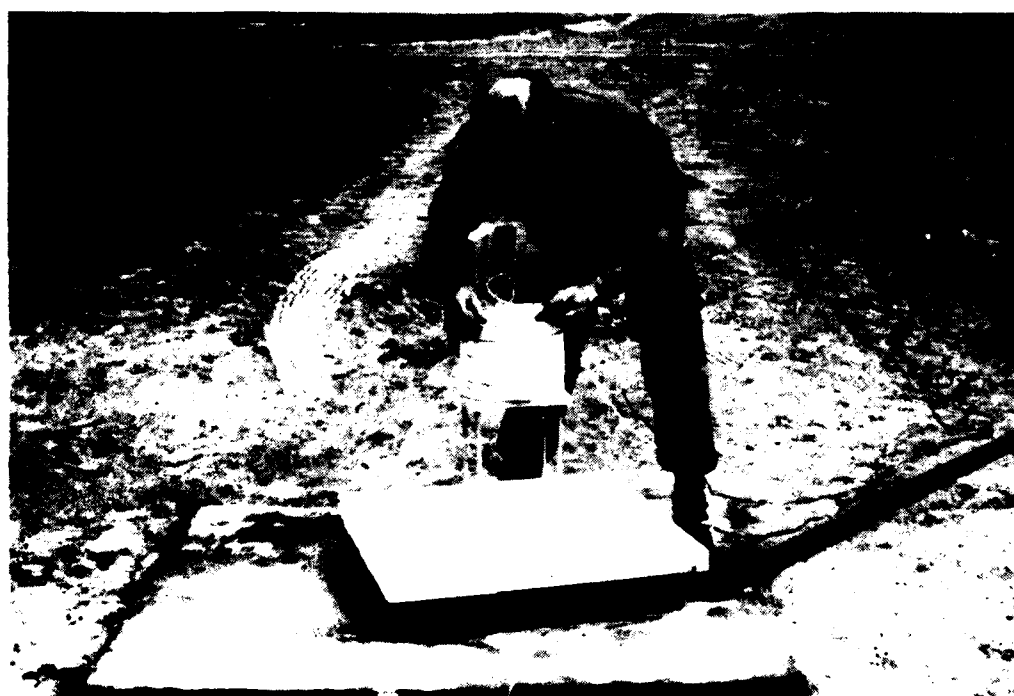
FIGURE 4 Blasting set-up. Inserting detonator into explosive charge, which is located on a flimsy wooden table over the centre of the plate. The test plate is white with frost cover. Thermocouple is inserted into front edge of test plate, with compensating lead protected by the angle-iron.

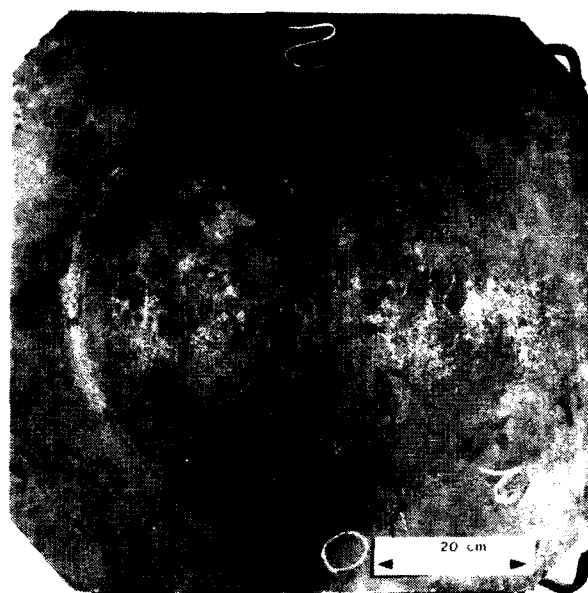
FIGURE 5 Bottom surface of plate 2 (Series 1) showing the ring marking the line of contact between the plate and die block at the time of blasting. A plate fails the test if cracking extends outside this ring (as shown here).

- (i) If no cracks exist but insufficient reduction in thickness had been obtained, the plate is returned to the cooling bath for additional testing.
- (ii) Failure occurs if cracking enters the hold down region (see Fig. 5) of the plate and the required 16 percent reduction in thickness has not been achieved. Additionally, no fragments are to be thrown out of the test specimen.
- (iii) Success occurs if the plate achieves a 16 percent reduction in thickness (with or without minor cracking) at a location adjacent to the weld, ie about 10 mm distant from the weld toe.
- (iv) If minor cracking exists, and the plate has not achieved the required 16 percent reduction in thickness, subsequent action is determined by the scientific officer in charge of the testing program.

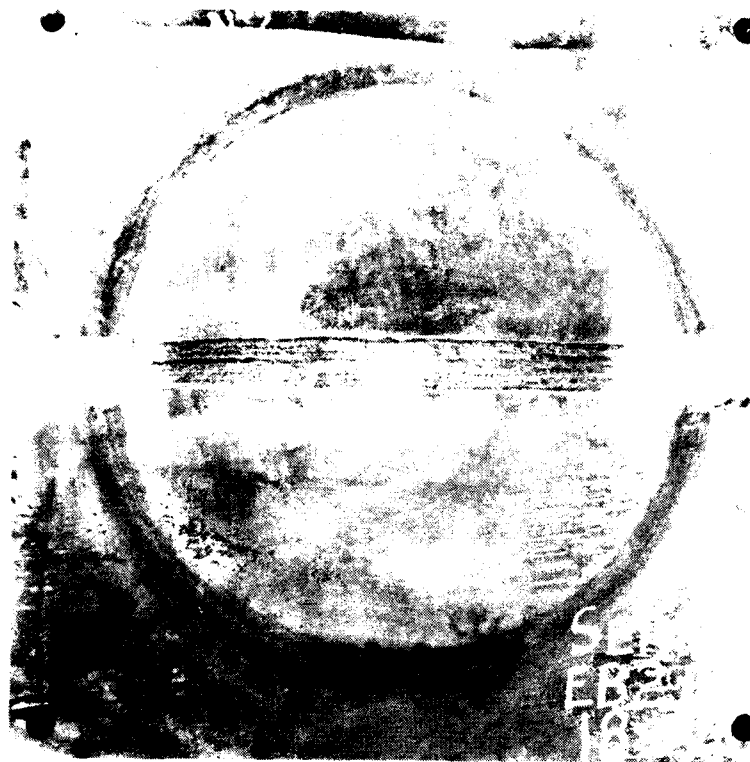
FIGURE 18 Explosion bulge plate number 2, at completion of testing.

The second plate achieved a reduction in thickness of 18% after four blasts. The plate surface (Fig. 18) showed minor cracking at the fusion boundary, the junction between the heat affected zone (HAZ) and the parent metal, and two short cracks between adjacent capping passes on the weld crown.

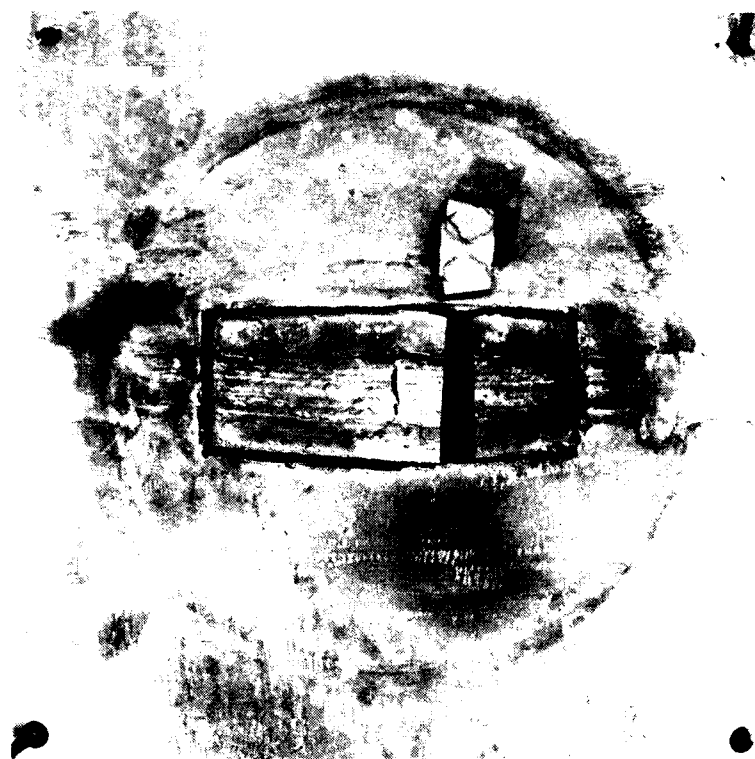
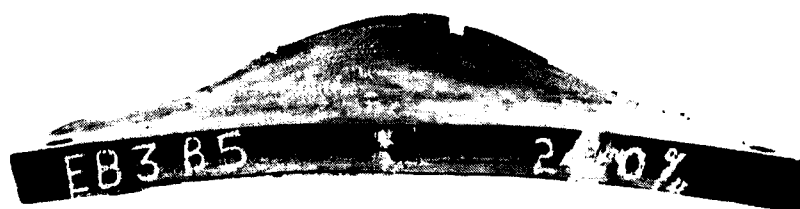
FIGURE 19 Explosion bulge plate number 3, at completion of testing. Section removed from the centre of the plate was for metallographic examination (see Fig. 21).

The third plate was subjected to five blasts and achieved a total reduction in thickness of 24% (Fig. 19). The plate showed cracking at both weld toes and some cracking along the junction between the HAZ and the parent metal. One crack occurred across the weld and two short cracks appeared between adjacent capping passes. None of these cracks was through-thickness and none came close to the ring marking the hold-down location of the die block.

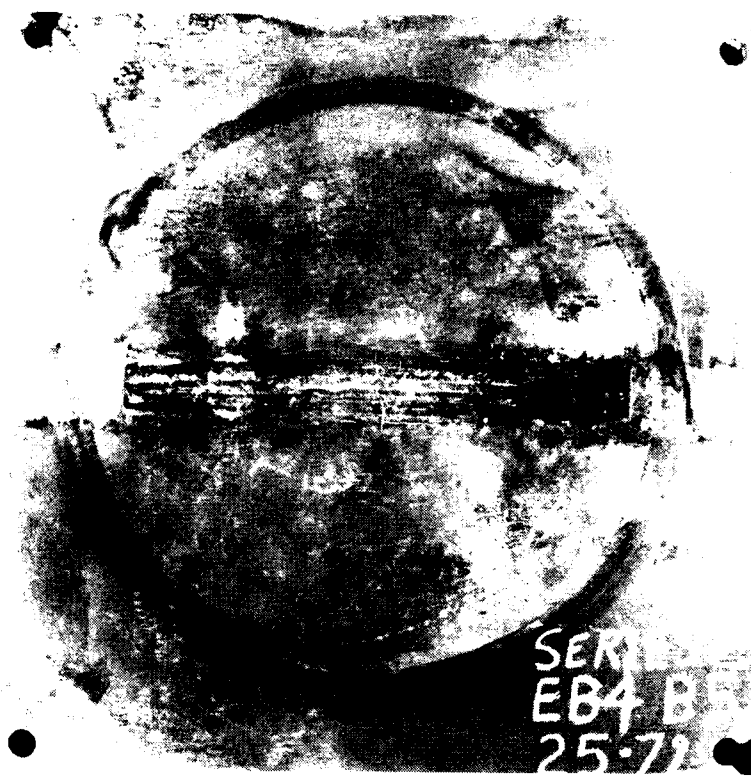
FIGURE 20 Explosion bulge plate number 4, at completion of testing.

The fourth plate (Fig. 20) achieved 25.7% reduction in thickness after 5 blasts. The plate exhibited three weld metal cracks about 40, 30 and 25 mm in length respectively. The first two of these cracks grew slightly into parent metal. There was also some minor cracking along the fusion boundary.
